## Exposure of LDEF Materials to Atomic Oxygen: Results of EOIM-III

15 July 1995

M. J. MESHISHNEK, C. H. JAGGERS, and C. S. HEMMINGER  
Mechanics and Materials Technology Center  
Technology Operations

6. AUTHOR(S)  M. J. Meshishnek, C. H. Jaggers, and C. S. Hemminger			
7. PERFORMING ORGANIZATION NAME(S) AND ADDRESS(ES)  The Aerospace Corporation Technology Operations El Segundo, CA 90245-4691		8. PERFORMING ORGANIZATION REPORT NUMBER  TR-94(4935)-12

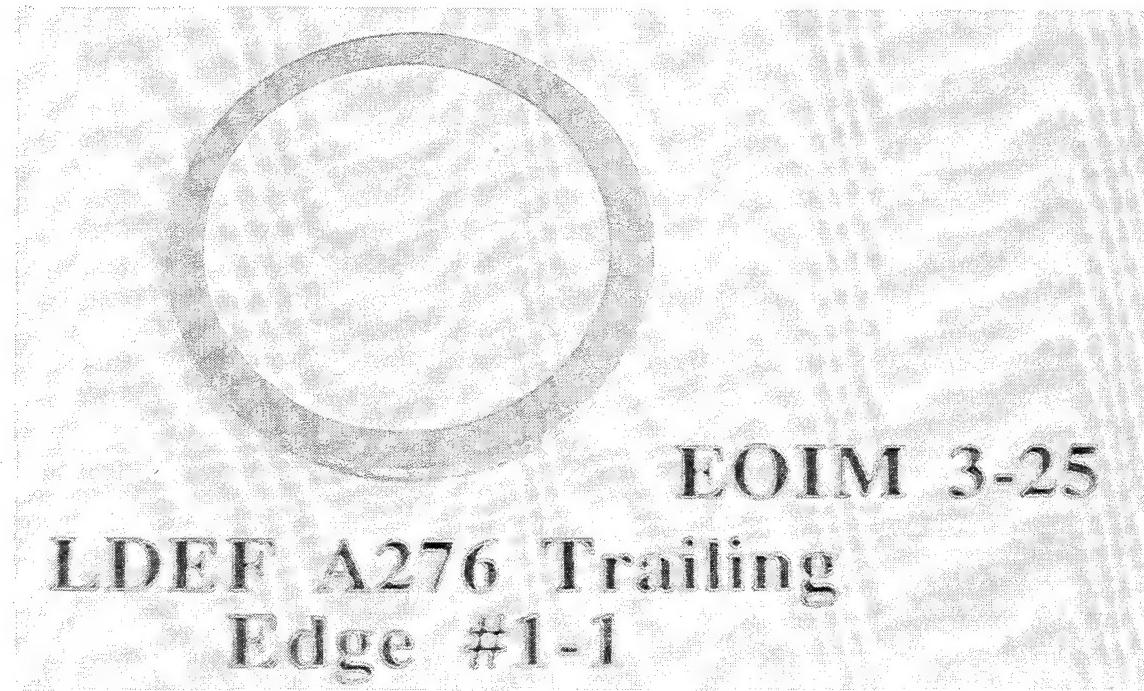
The trailing-edge LDEF sample (EOIM3-1-1) of Chemglaze A276 showed marked changes due to the EOIM-III exposure, as expected. Visual inspection revealed that the sample changed from brown to white during the experiment, and the surface became more diffuse. A photograph of the post-flight sample is shown in Figure 1. The UV-VIS-NIR spectra (Figure 2) show increased reflectance after the exposure and that the change in the material primarily occurred in the visible-wavelength range. The solar absorptance decreased from 0.528 to 0.295 (Table 2).

Figure 1. Post-flight photograph of EOIM3-1-1, Chemglaze A276 LDEF TE.

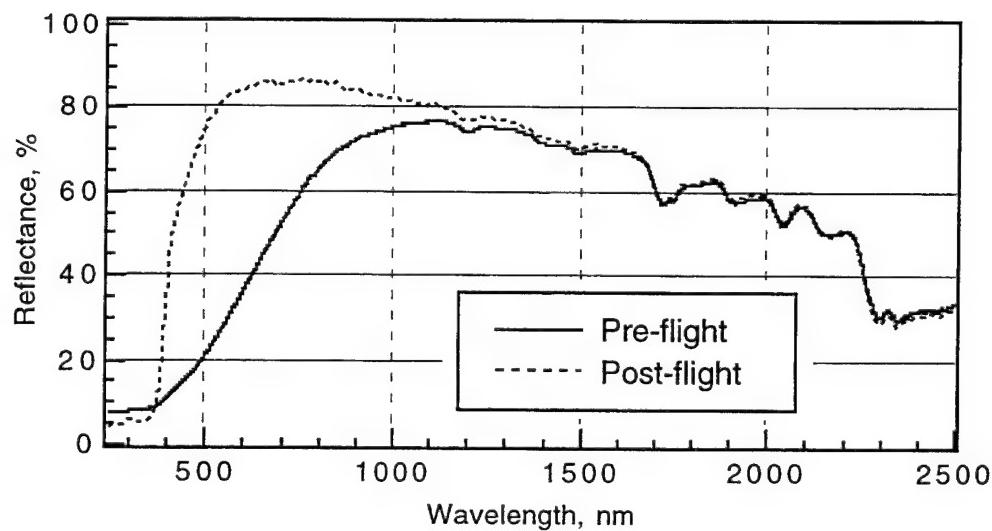
Figure 2. Reflectance spectra of EOIM3-1-1, Chemglaze A276 LDEF TE, before and after atomic-oxygen exposure.

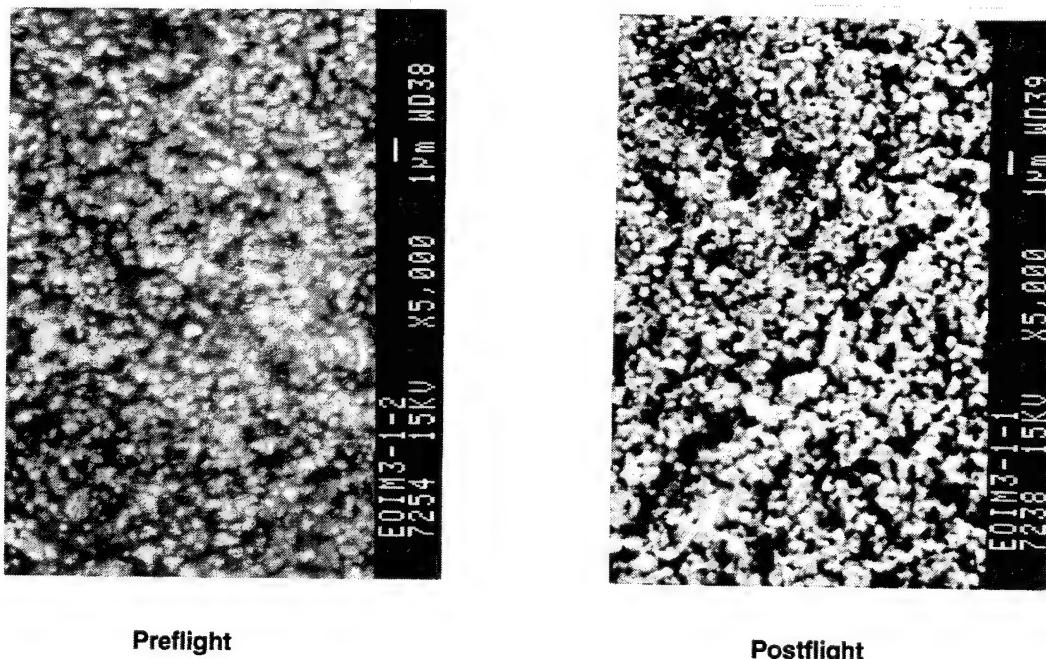
Investigation of the surface morphology by SEM (Figure 3) indicates the expected changes due to the atomic oxygen exposure. The flight sample, in comparison to the ground control, indicates a significant roughening of the surface from erosion. The control sample, which has not been exposed to significant amounts of atomic oxygen, appears to be relatively intact with the titanium dioxide pigment particles dispersed throughout the polyurethane binder. However, the polyurethane binder on the surface of the flight sample was eroded away, leaving a surface that is primarily titanium dioxide pigment. These differences were also seen between LDEF leading- and trailing-edge samples.<sup>1,3</sup>

Figure 3. SEM photographs of EOIM3-1-1, Chemglaze A276 LDEF TE, before (left) and after (right) atomic oxygen exposure.

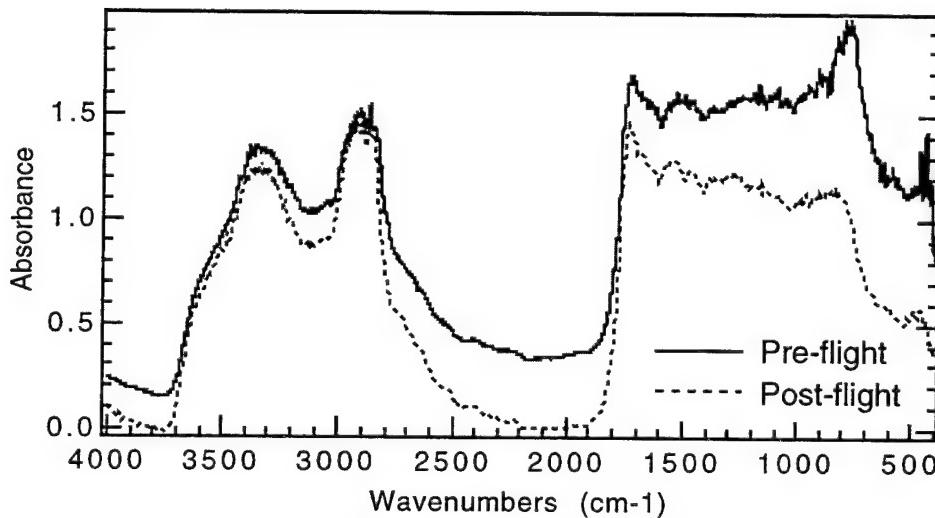
The preflight and postflight FTIR spectra of the Chemglaze A276 sample are shown in Figure 4. There is an apparent reduction in infrared absorption throughout the wavelength range, suggesting a thinning of the polyurethane binder layer from atomic-oxygen erosion. This is consistent with the SEM observations. However, no significant spectral shifts or intensity-ratio changes were observed, suggesting uniform erosion of the polyurethane. There appears to be a small change in the absorption ratio at  $750\text{ cm}^{-1}$ , which may be due to removal of aromatic hydrogens in the polyurethane.

Figure 4. FTIR spectra of EOIM3-1-1, Chemglaze A276 LDEF TE, before and after atomic-oxygen exposure.

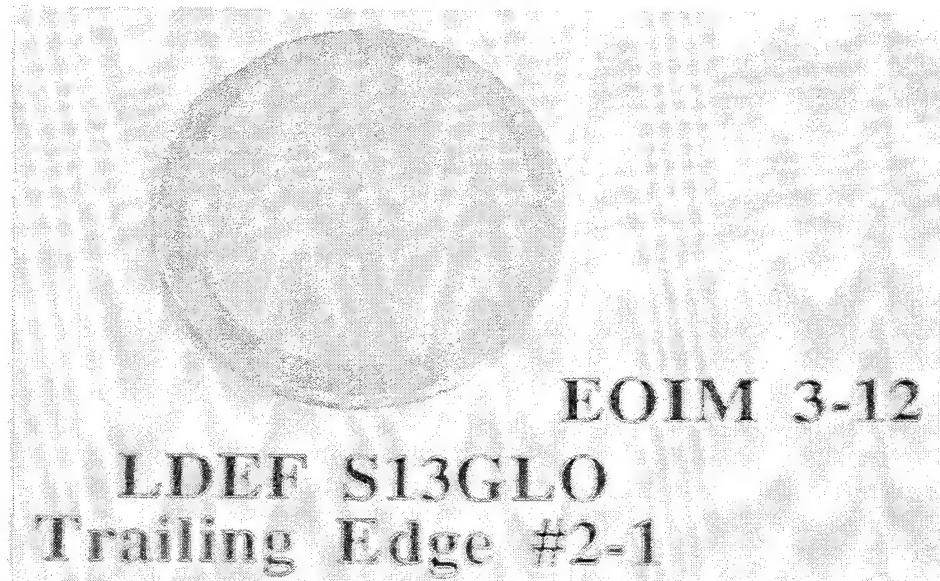
The S13GLO sample from the trailing edge of LDEF visually appeared whiter in comparison to the control sample and to the masked region of the flight sample (Figure 5). The sample exhibited increased post-flight reflectance in the visible wavelength range (Figure 6), resulting in a decreased solar absorptance from 0.417 to 0.355 (Table 1).

Figure 5. Post-flight photograph of EOIM3-2-1, S13GLO LDEF TE

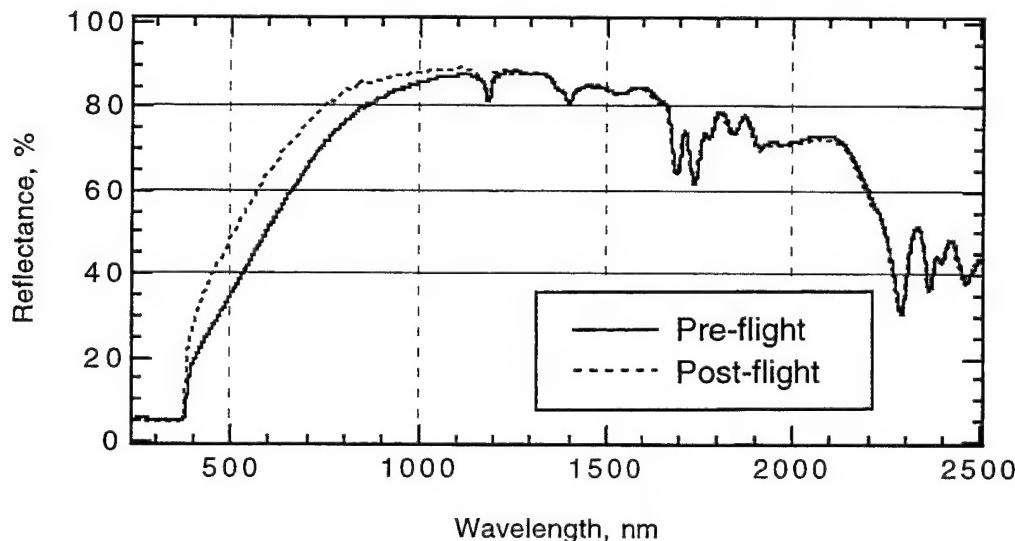
Figure 6. Reflectance spectra of EOIM3-2-1, S13GLO LDEF TE, before and after atomic oxygen exposure.

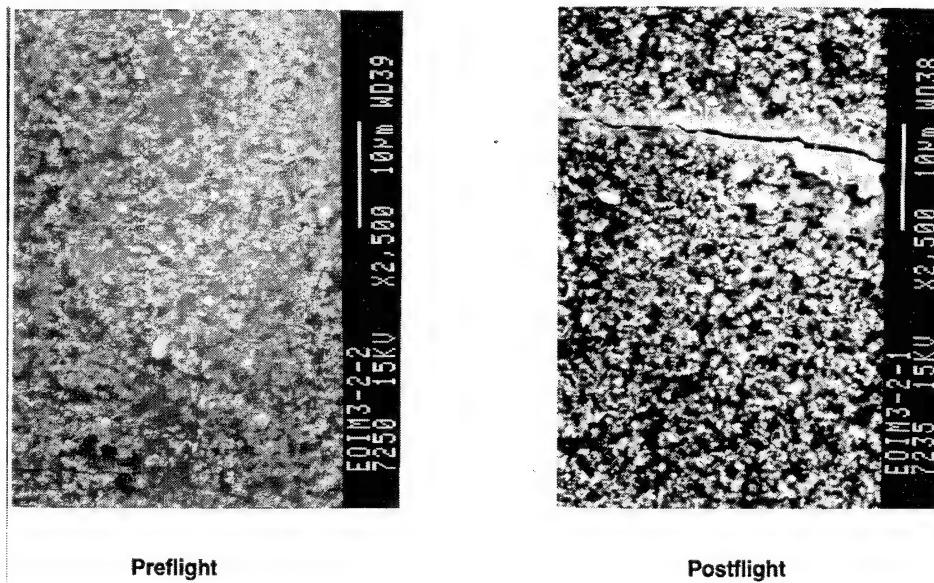
Investigation of the surface morphology with SEM (Figure 7) indicates that exposure to atomic oxygen resulted in minor changes. The surface of the flight sample appears to have been slightly eroded by atomic oxygen, although not as extensively as the Chemglaze A276 sample. As with Chemglaze A276, the erosion was probably due to atomic oxygen erosion of the binder. However, in this case, erosion of the silicone is much less than the polyurethane used in the Chemglaze paints. Erosion of the S13GLO binder was not observed on M0003 LDEF samples.<sup>1,3</sup>

Figure 7. SEM photographs of EOIM3-2-1, S13GLO LDEF TE, before (left) and after (right) atomic oxygen exposure.

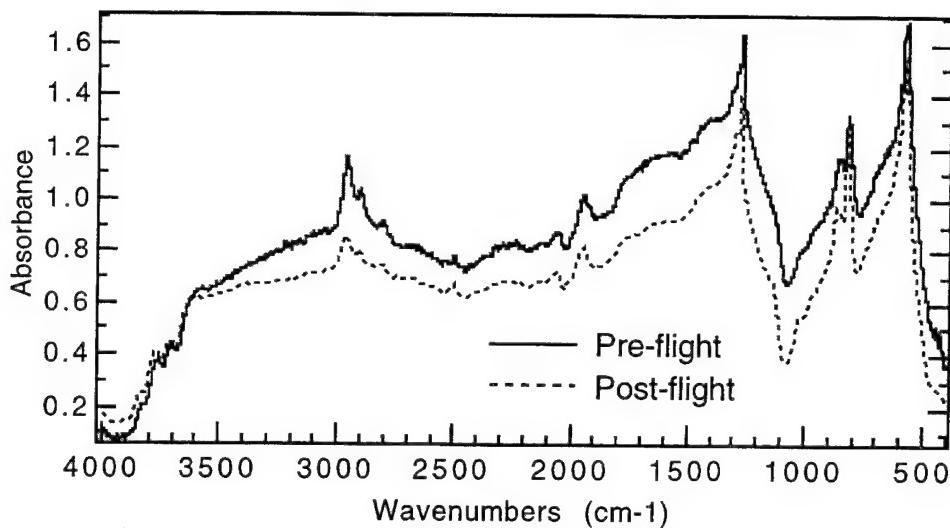
Figure 8 gives the pre-flight and post-flight FTIR spectra for the TE S13GLO sample. Some decreased absorbance is noted for the sample after the exposure. There is a significant but small decrease in the absorption at  $3000\text{ cm}^{-1}$  due to the C-H stretch, indicating oxidative removal of the methyl groups attached to the silicone polymer. This effect has been observed on earlier EOIM flights.<sup>13</sup>

Figure 8. FTIR spectra of EOIM3-2-1, S13GLO LDEF TE, before and after atomic oxygen exposure.

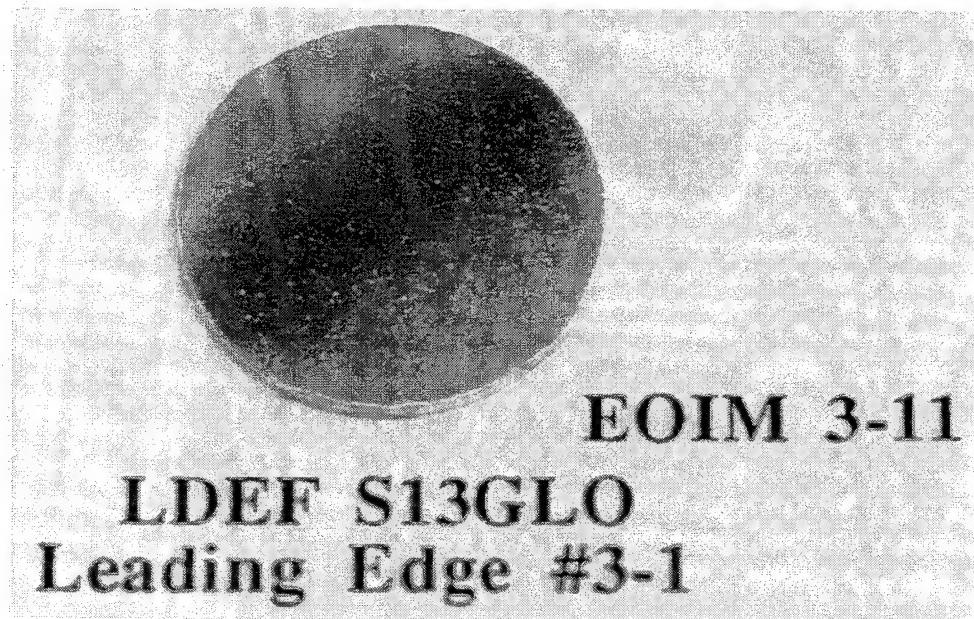
The S13GLO sample from the side of the SCU cover on the leading edge of LDEF was recovered still visibly contaminated with a brown "nicotine" stain. The post-flight photo of this sample is shown in Figure 9. The reflectance spectra in Figure 10 indicate very little change resulting from atomic oxygen exposure; the solar absorptance increased insignificantly from 0.507 to 0.515 (Table 2).

Figure 9. Post-flight photo of EOIM3-3-1, S13GLO LDEF LE (contaminated).

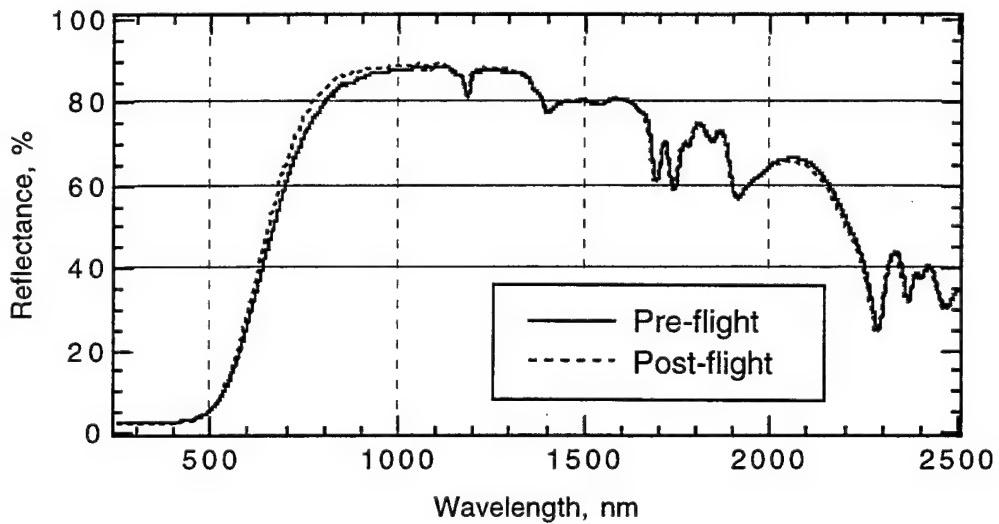
Figure 10. Reflectance spectra of EOIM3-3-1, S13GLO LDEF LE (contaminated), before and after atomic oxygen exposure.

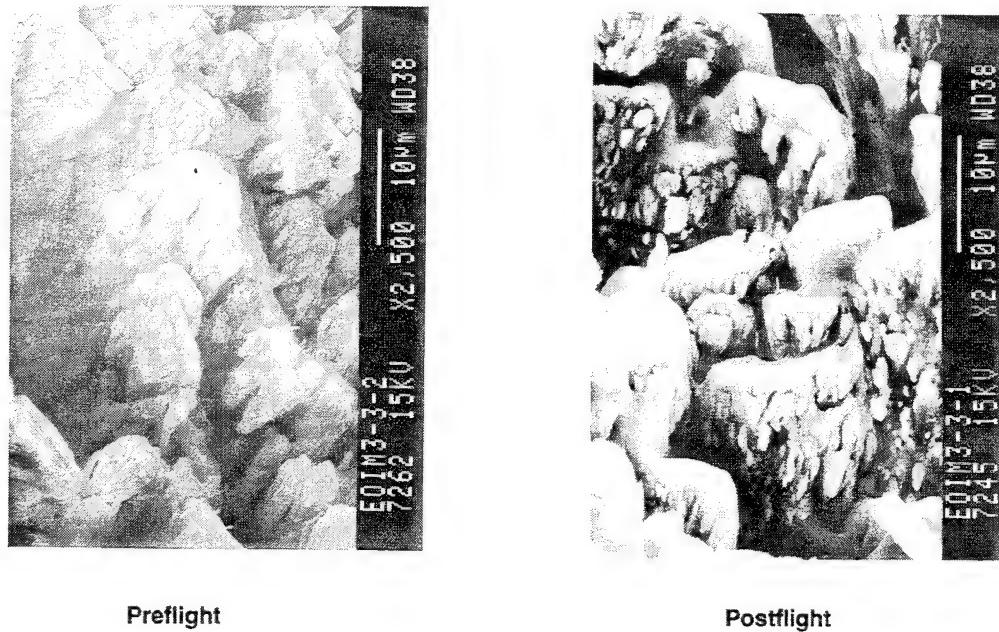
The SEM photographs in Figure 11 show a significantly different surface morphology than the S13GLO LDEF TE sample, presumably due to the contamination layer. From the SEM photographs, it appears that the contamination layer grows from nucleation sites on the surface in an upward direction, away from the surface. Both the flight sample (after atomic oxygen exposure) and the control sample (no atomic oxygen exposure) have similar surface morphologies, indicating that atomic oxygen had little effect on this contamination layer.

Figure 11. SEM photographs of EOIM3-3-1, S13GLO LDEF LE (contaminated), before (left) and after (right) atomic oxygen exposure.

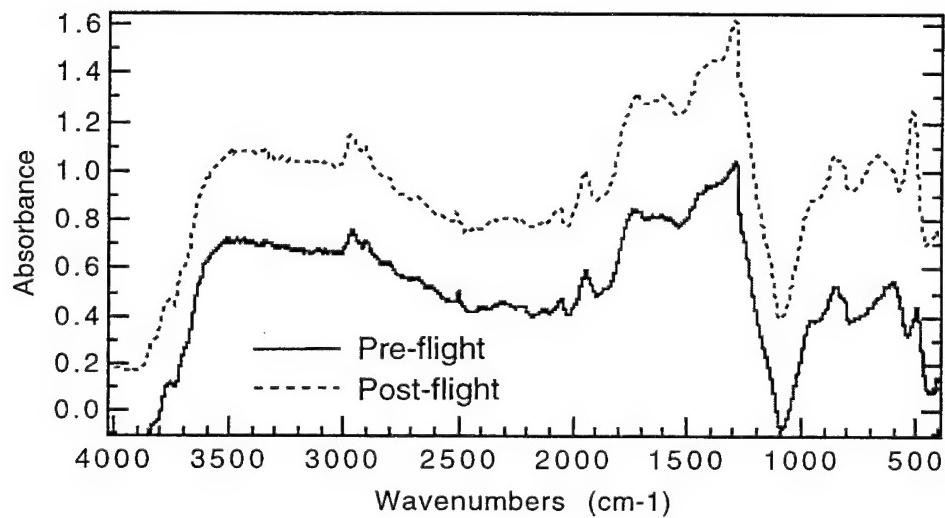
The FTIR spectra for the LE S13GLO sample are given in Figure 12. Essentially no changes occurred due to the atomic oxygen exposure. Overall absorption changes are evident due to thickness differences in different areas of the paint sample.

Figure 12. FTIR spectra of EOIM3-3-1, S13GLO LDEF LE (contaminated), before and after atomic oxygen exposure.

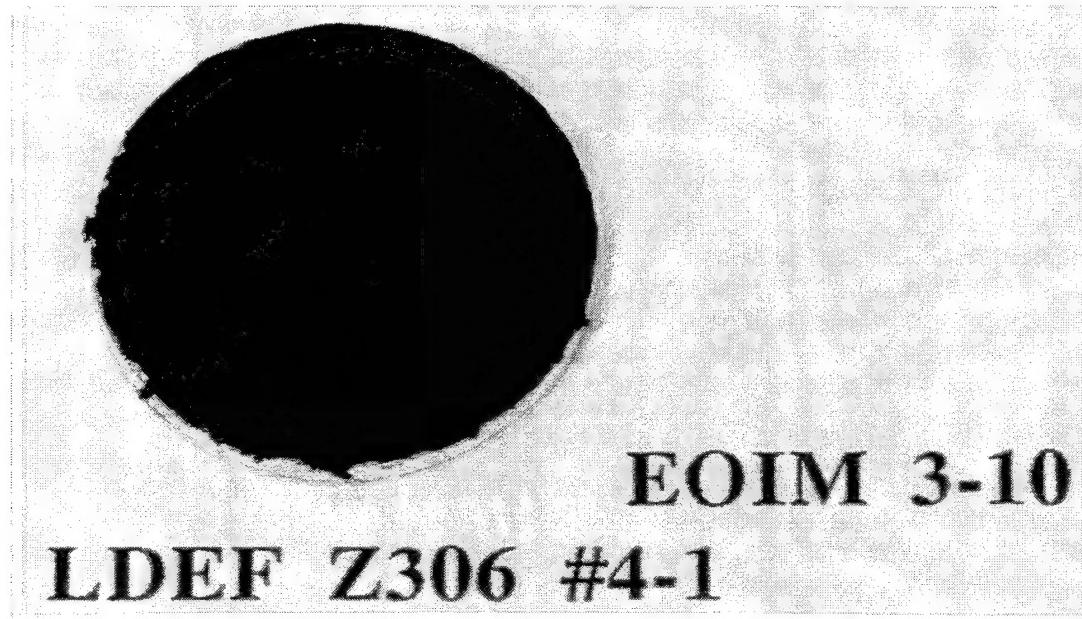
The sample of Z306 from the trailing edge of LDEF flown on EOIM-III exhibited only a slight change in its reflectance post-flight, resulting in a negligible increase in its solar absorptance from 0.955 to 0.960 (Table 2). Visually the sample appeared the same as before the flight (Figure 13). The reflectance spectra are shown in Figure 14. However, XPS and SEM results indicate that significant changes did occur due to atomic oxygen erosion.

Figure 13. Post-flight photo of EOIM3-4-1, Z306 LDEF TE (contaminated).

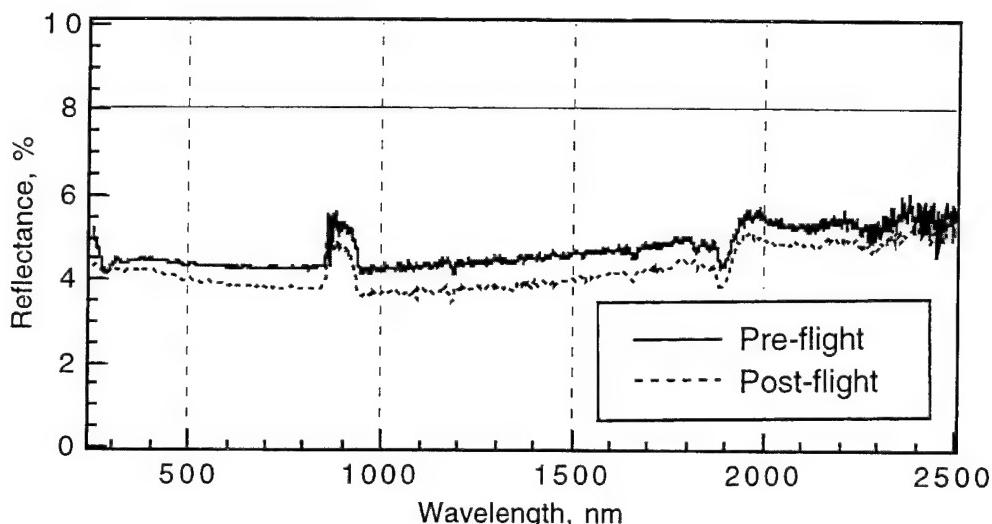
Figure 14. Reflectance spectra of EOIM3-4-1, Z306 LDEF TE (contaminated), before and after atomic oxygen exposure.

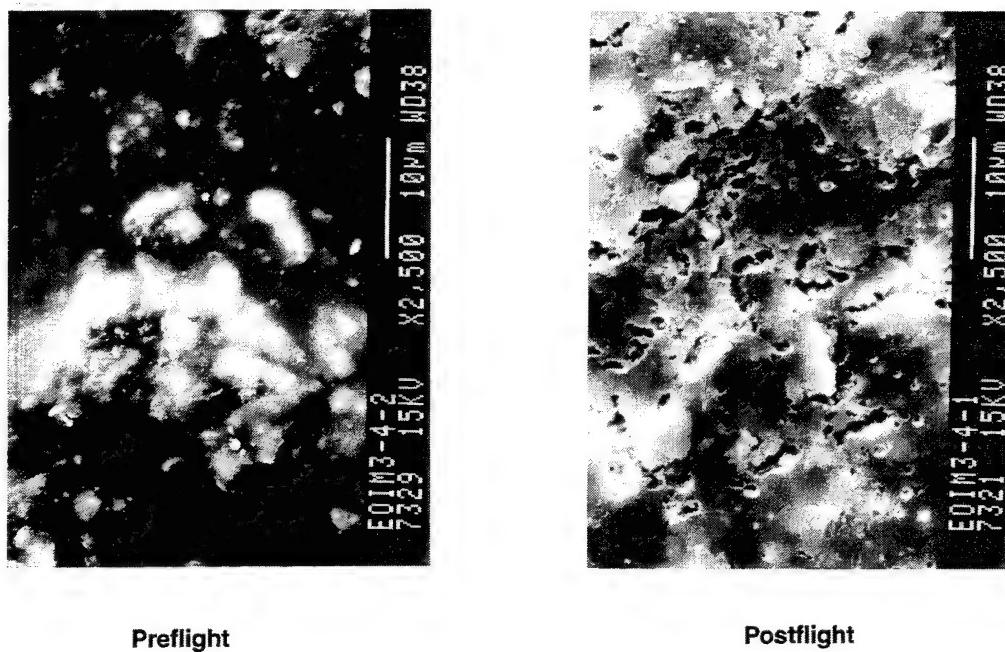
The surface morphology of the Z306 sample was clearly altered, as indicated by the SEM photographs in Figure 15. The flight sample has what appears to be a pitted or cratered surface, where portions of the surface were eroded away. This effect is not uniform across the surface, resulting in fairly large craters or pits. In contrast, the control sample has a fairly uniform texture, evenly distributed over the entire surface. The reasons for this erosion behavior are not understood.

Figure 15. SEM photographs of EOIM3-4-1, Z306 LDEF TE (contaminated), before (left) and after (right) atomic oxygen exposure.

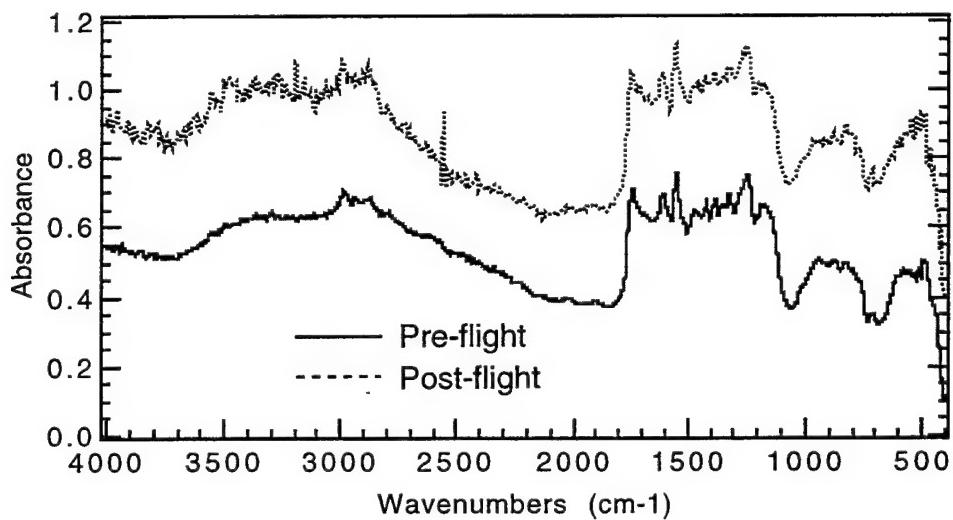
The FTIR spectra for this sample as shown in Figure 16 do not indicate any significant chemical changes in the sample due to the atomic oxygen exposure.

Figure 16. FTIR spectra of EOIM3-4-1, Z306 LDEF TE (contaminated), before and after atomic oxygen exposure.

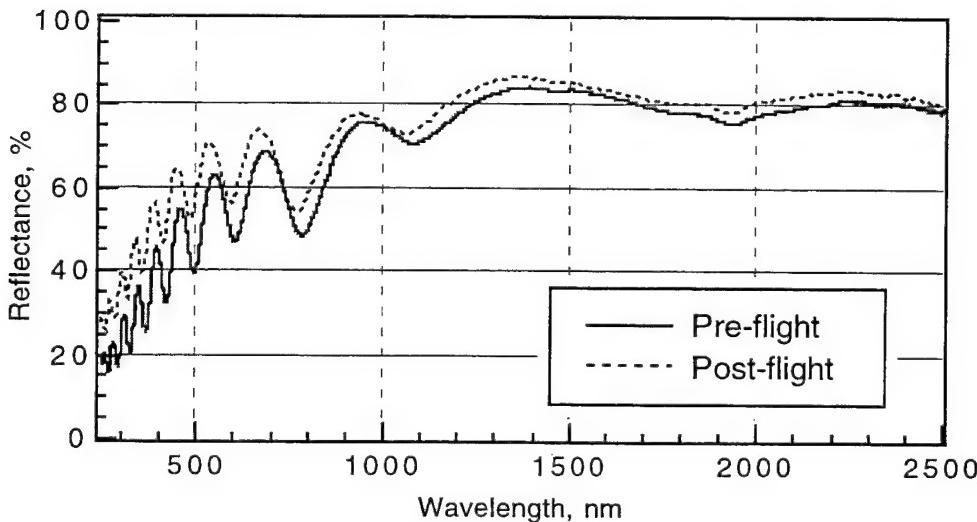
Figure 18. Reflectance spectra of EOIM3-5-1, anodized aluminum LDEF TE (contaminated), before and after atomic oxygen exposure.

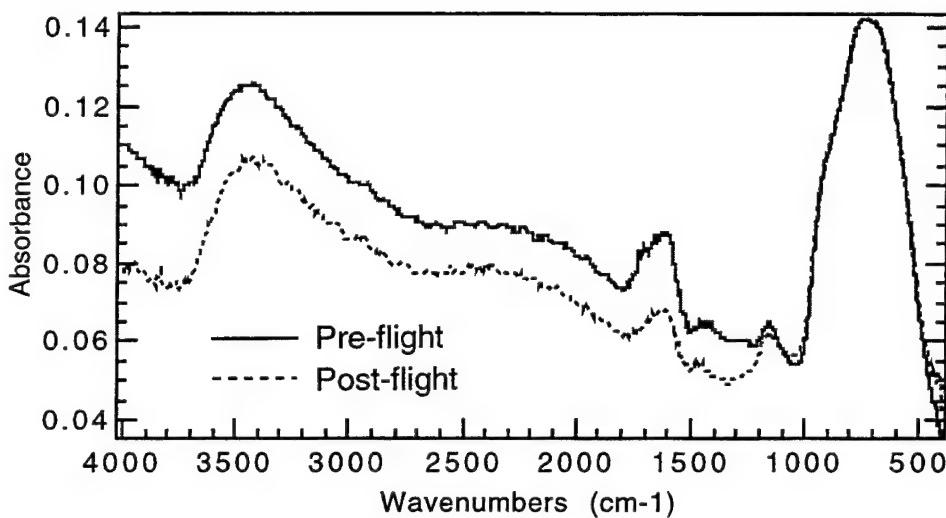
Figure 19. FTIR spectra of EOIM3-5-1, anodized aluminum LDEF TE (contaminated), before and after atomic oxygen exposure.

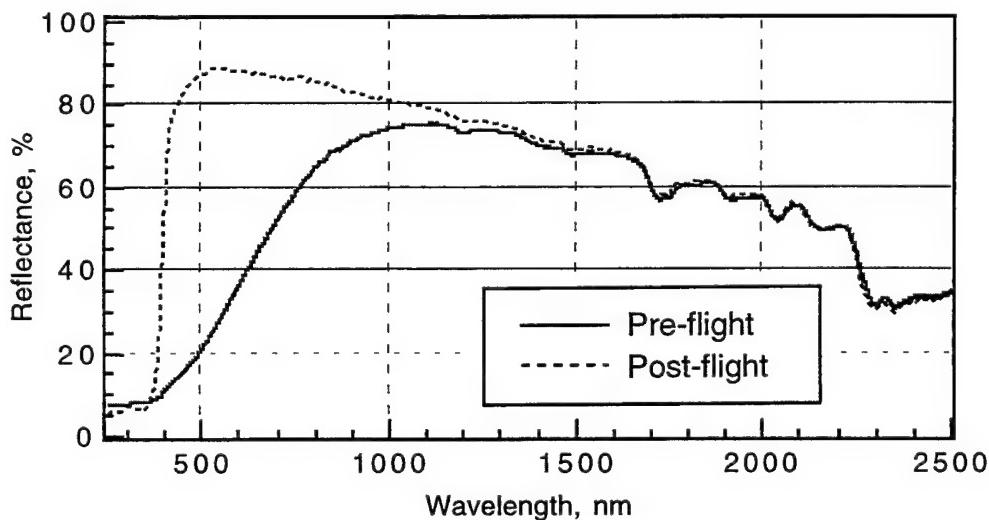
The LANL Chemglaze A276 sample showed similar effects to the EOIM-III flight sample. Visually, the sample changed from brown to white, as evidenced by the increased reflectance below 1500 nm (Figure 20) and the decreased solar absorptance from 0.536 to 0.258 (Table 2). In comparison with the reflectance data obtained from EOIM-III on the same material, the LANL paint sample exhibited greater increased reflectance post-test than the flight sample. Since both samples received the same atomic oxygen dose, the reasons for this are not clear.

Figure 20. Reflectance spectra of EOIM3-1-3, Chemglaze A276 LDEF TE, before and after atomic oxygen exposure at LANL.

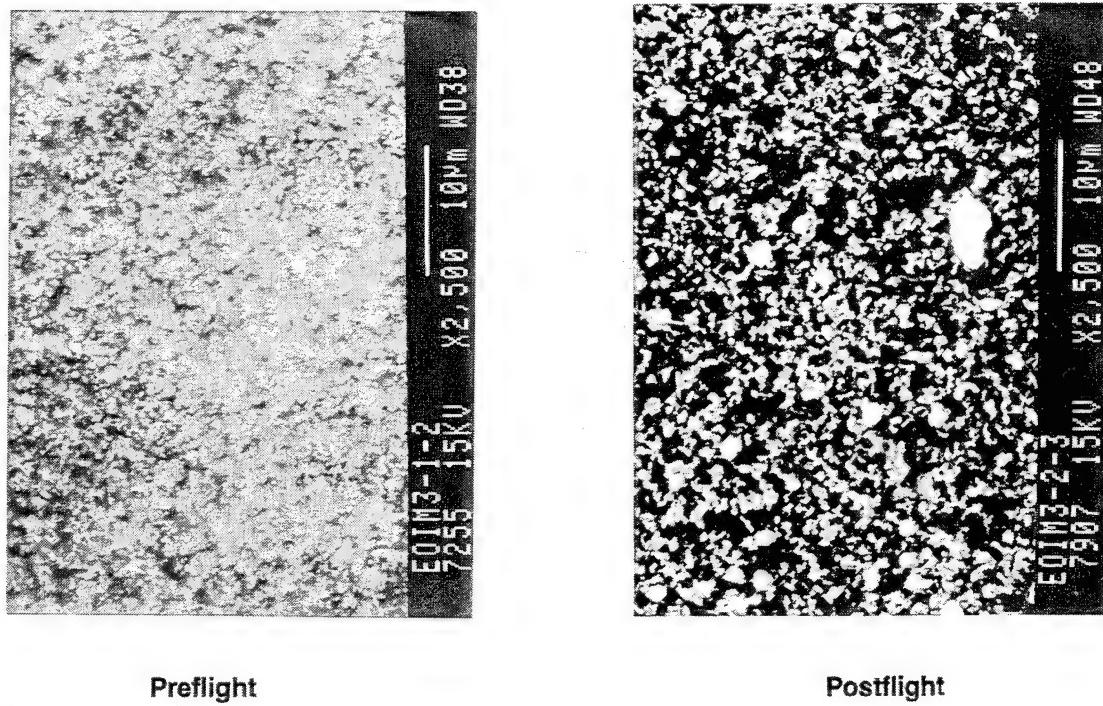
Atomic oxygen erosion of the polyurethane binder accounts for the changes in the surface morphology, as evident in the SEM photographs in Figure 21. Like the EOIM-III flight sample, exposure of the sample to atomic oxygen at LANL resulted in preferential erosion of the polyurethane binder, resulting in enrichment of titanium dioxide pigment at the surface.

Figure 21. SEM photographs of EOIM3-1-3, Chemglaze A276 LDEF TE, before (left) and after (right) atomic oxygen exposure at LANL.

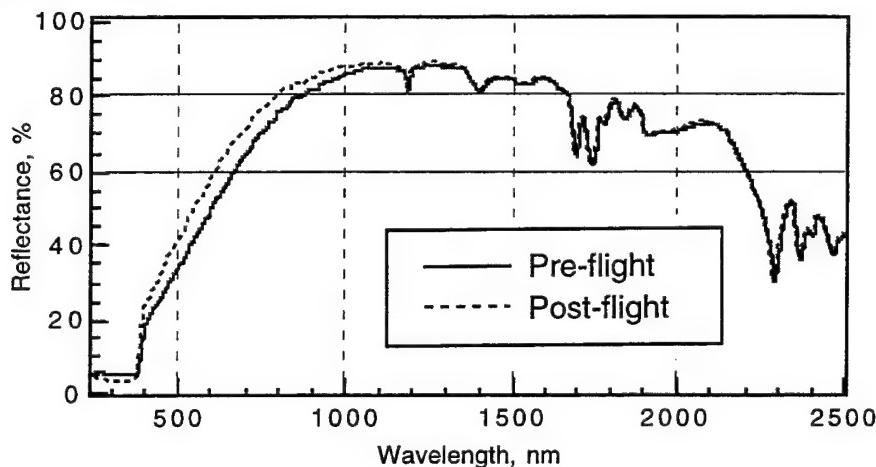
The S13GLO TE sample lightened during the ground-based atomic oxygen exposure at LANL, but visually it did not lighten as much as the EOIM-III flight sample. However, the change in the reflectance curve (Figure 22) is similar to the change observed for the flight sample (Figure 6). The change in solar absorptance from 0.422 to 0.386 is a little over half that observed for the flight sample (Table 2).

Figure 22. Reflectance spectra of EOIM3-2-3, S13GLO LDEF TE, before and after atomic oxygen exposure at LANL.

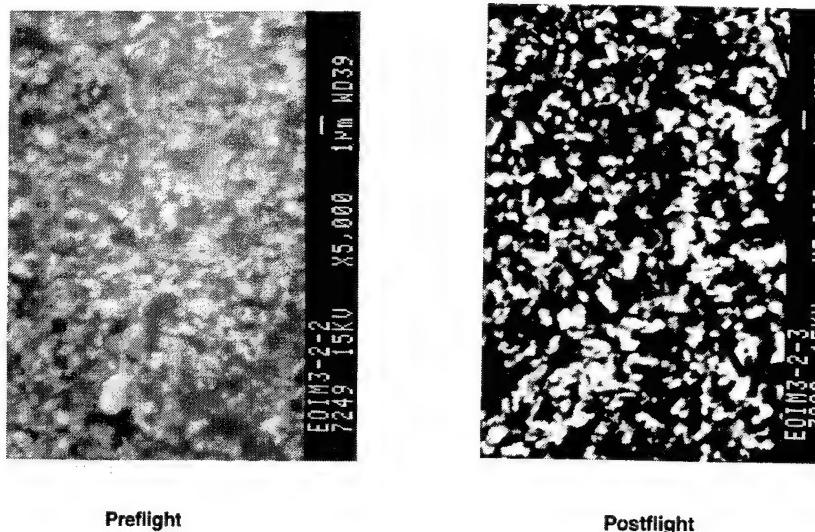
Investigation of the surface morphology with SEM (Figure 23) shows slight changes due to atomic-oxygen exposure. These changes are minor and, again, qualitatively less than observed for the EOIM-III sample.

Figure 23. SEM photographs of EOIM3-2-3, S13GLO LDEF TE, before (left) and after (right) atomic oxygen exposure at LANL.
